INSPECTION REPORT Sample Inspection Report Wellington FL 33414

INSPECTED BY Jessica Dumais Florida Wisdom Home Inspections LLC HI14781 INSPECTION DATE 11/20/2022 09:00 AM

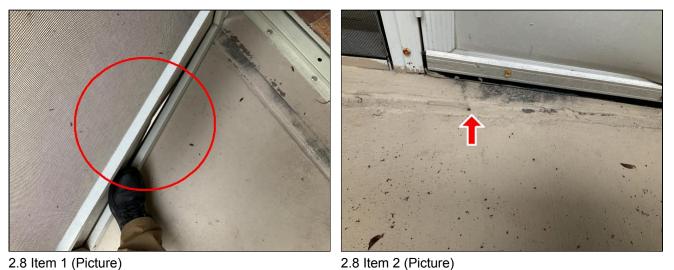
Minor damage to the screen door was observed. The doors is rubbing the floor upon opening and the screen is torn at the bottom. It needs to be adjusted and repaired. Repair cost estimate by a screen enclosure company is required prior to closing.

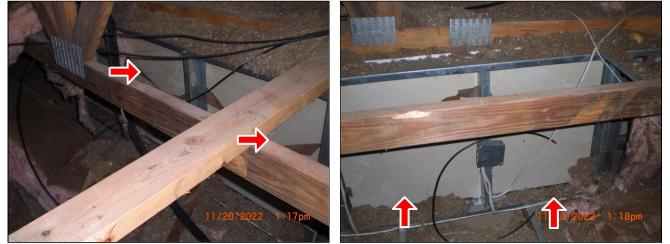
4.2 Item 1 (Picture)

- (3) The batt insulation has fallen down at the attic side walls. The insulation needs to be re-installed and properly secured by a licensed insulation contractor to provide the required thermal barrier and energy efficiency. Repair cost estimate is required prior to closing.

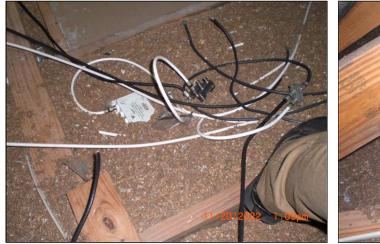
6.8 Item 1 (Picture)

+ Open and/or improper electrical splices were observed throughout the attic space above the garage and above the bedrooms. Electrical connections are required to be installed inside a junction box for safety. A licensed electrician must walk the entire attic space and make repairs to all incorrect splice connections. Repair cost estimate by a licensed electrician is required prior to closing.

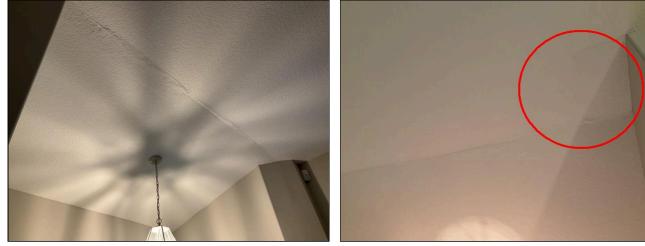
8.0 Item 1 (Picture)

The ceiling reveals hairline cracks in multiple areas. The tape at the seams might be missing and/or those lines can be from high home humidity levels. Contraction and expansion of the ceiling is common and causes ceiling cracks. The ceiling can be re-finished by a licensed contractor. This involve texture removal, application of fresh compound, and new paint. If the cracks open again or open wider, further evaluation by a structural engineer will be needed. Monitoring the crack is required. The ceilings textured finishes increase the difficulty in matching the existing finish, complicate, and increase the cost of repairs.

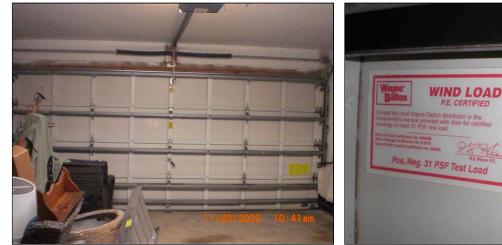
11.4 Item 4 (Picture)

(3) When raised manually, the garage door springs do not prevent the door from falling down without warning and won't stay open. It needs to be adjusted for proper operation. This is a safety hazard. DO NOT use the garage door manually until this issue is fixed. Repair cost estimate by a garage door technician is required prior to closing.

(4) The original garage door is only wind rated. When it needs to be replaced, the inspector recommend upgrading to an impact rated door. The additional cost is negligible and this will qualify you for an additional discount of of your homeowners insurance policy.

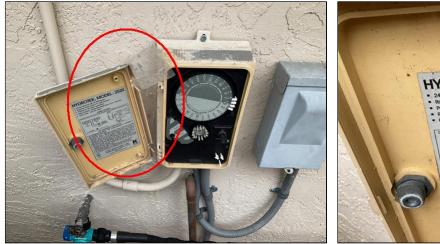
12.1 Item 1 (Picture)

(1) The control box cover for the sprinkler system was damaged at the time of the inspection. Replacement cost estimate is required prior to closing.

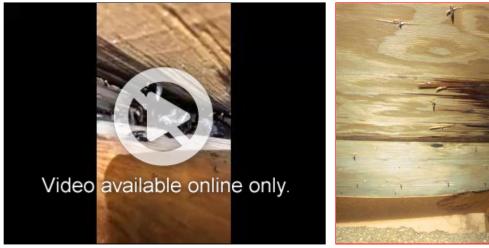
1.6 Item 1 (Video)

(1) The roof sheathing is deteriorated and soft at multiple areas. The leaks are currently active. Due to the roof age, it is not cost effective to perform repairs. The roof must be replaced. Until then, a plastic sheeting cover must be installed by a roofing company to avoid any further leak damages. Replacement cost estimate by a licensed roofing contractor is required prior to closing.

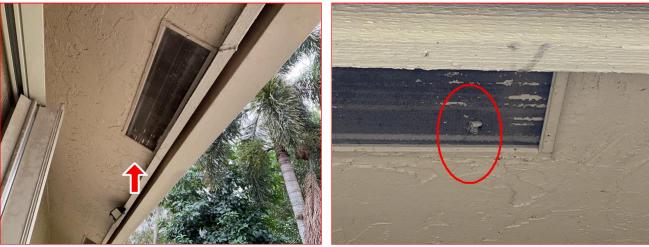
2.3 Item 2 (Picture)

(2) The soffit vent is damaged. All soffit vents must be covered and secured with a heavy duty galvanized screen to keep animals/insects out while allowing air movement. The vents should not be perforated. Repair cost estimate is required prior to closing.

The old/disconnected wire installed through the soffit vent screen must be removed or covered with a wire cap.

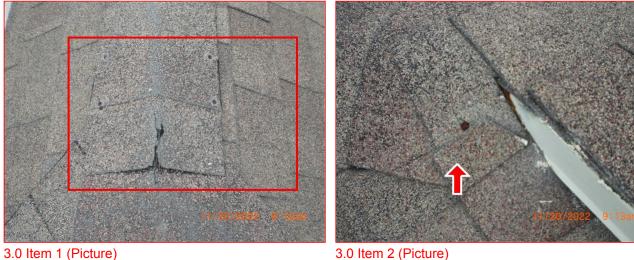
3.0 Item 1 (Picture)

(1) The roof covering is beyond it's useful life as evidenced by missing/torned shingle tabs, exposed fasteners, exposed shingle mat, deteriorated shingles, excessive granule lost, and visible roof leaks. The roof needs to be replaced ASAP to prevent failures. Replacement cost estimate by a licensed roofing contractor is required prior to closing.

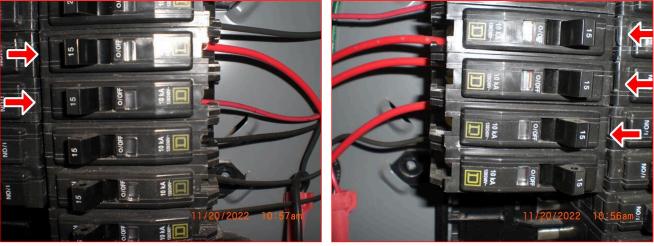
6.1 Item 2 (Picture)

(2) Breaker rated for 15 Amps are usually for lights and receptacles. They must be connected with a #14 copper wire. At the time of the inspection, the wire size was incorrect. Further evaluation by a licensed electrician is required prior to closing.

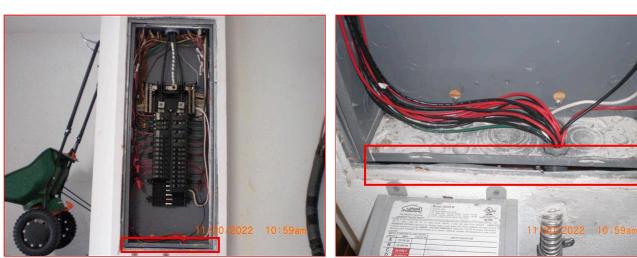
```
6.1 Item 4 (Picture)
```

(3) An open gap into the wood frame wall exists between the metal panel box and the wall finish. This is required to be filled/sealed to avoid fire spread inside the walls. Fire rated expanding foam is the easiest way to seal this gap. Repair cost estimate by a licensed handyman is required prior to closing.

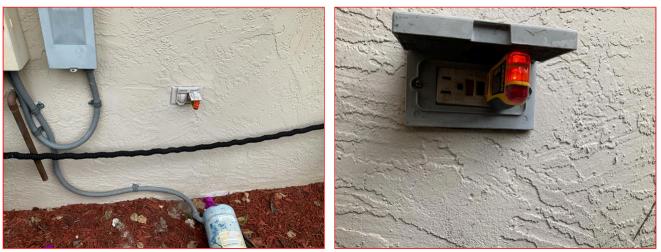
6.6 Item 1 (Picture)

(1) The GFCI receptacles at the house exterior are faulty. The receptacles might be malfunctioning or they might not be connected properly. The GFCI did not tripped when tested. Further evaluation is required by a licensed electrician prior to closing.

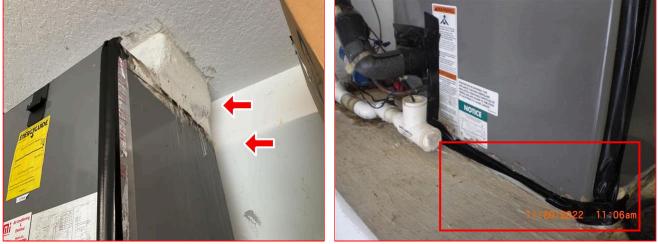
7.3 Item 1 (Picture)

(1) Visible discoloration, suspected microbial growth, and water marks were found where the ductwork and the AC handler interconnect. This suggest air leaks in between the two. Cold air in contact with hot air creates condensation water which then cause water damages. The duct tape must be removed and the AC handler must be re-sealed properly to avoid further damages. Further evaluation and repair cost estimate by a licensed HVAC contractor is required prior to closing.

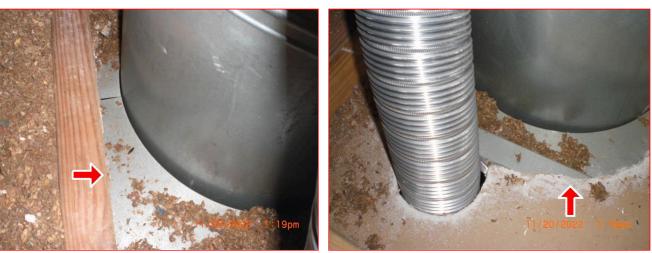
7.10 Item 1 (Picture)

(1) The attic insulation shield is used through the ceiling to prevent insulation and other debris from contacting the chimney in the attic. The attic insulation shield is placed above the ceiling support box on top of the framing of the ceiling where the chimney passes through the attic. None was installed. Cellulose insulation is made of recycle paper material. This is a fire safety hazard. Further evaluation and repair cost estimate by a professional chimney installer is required prior to closing.

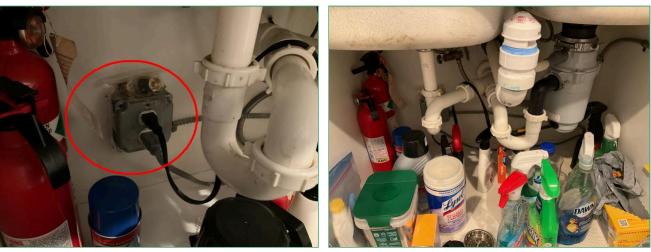
10.9 Item 1 (Picture)

(1) The dishwasher and the disposal are plugged into the same outlet. However, the electrical panel shows that they are under different circuits. Some appliances will simply use too much power to be safely used on the same circuit as other, and for this reason further evaluation by a licensed electrical contractor is required prior to closing.

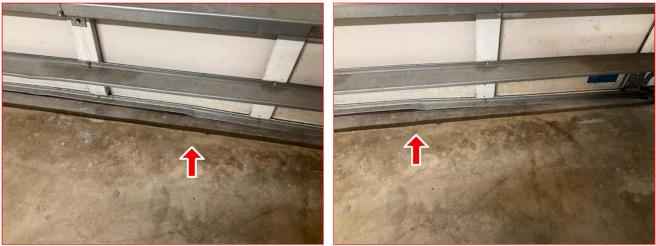
11.4 Item 2 (Picture)

(2) The garage door is damaged at the bottom left corner. It appears to have been hit. Follow up with the seller for explanation. The door is functional and operates properly at the time of the inspection.

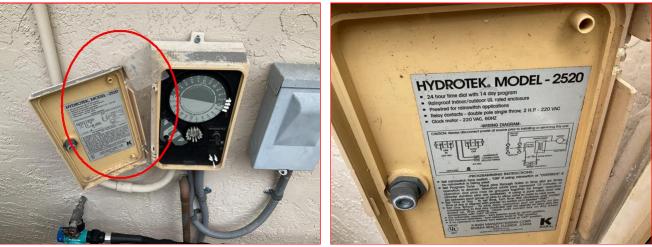
12.1 Item 1 (Picture)

(1) The control box cover for the sprinkler system was damaged at the time of the inspection. Replacement cost estimate is required prior to closing.

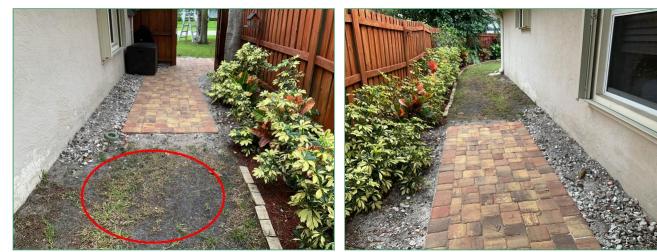
2.7 Item 1 (Picture)

(1) The pathway on the left side of the house is unfinished. Follow up with the seller prior to closing.

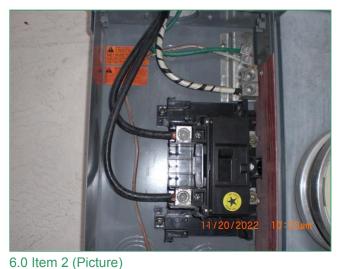
6.0 Item 1 (Picture)

The service conductor sizes have been guessed upon the opinion of the inspector. The service cables were unmarked at the time of the inspection. Follow up with a licensed electrician prior to closing if concerned.
