INSPECTION REPORT Sample Inspection Report Wellington FL 33414

INSPECTED BY Jessica Dumais Florida Wisdom Home Inspections LLC HI14781 INSPECTION DATE 11/20/2022 09:00 AM

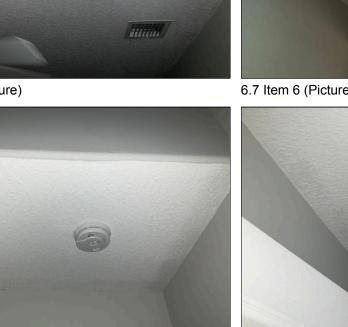
- (2) Replacing missing, inoperable or older smoke detectors is needed. The NFPA requires a smoke alarm on every
- Ievel and outside each sleeping area in existing construction. The NFPA requires smoke alarms to be installed inside each bedroom, outside each bedroom area, and on every level in new construction home. Per the Consumer Product Safety Commission, smoke detectors are only effective for 10 years. All detectors older than 10 years old need to be replaced. All smoke detectors must be tested upon moving into the home. For more information, please visit the NFPA website at: https://www.nfpa.org
